Building Inspection Report

Report Number: 030406A
Inspection Date: 2/1/05 1:30

Address: 3418 Hanford Lane, Ocala FL
Reported Square Footage: 2000
Approximate Age or Year Built: 1958

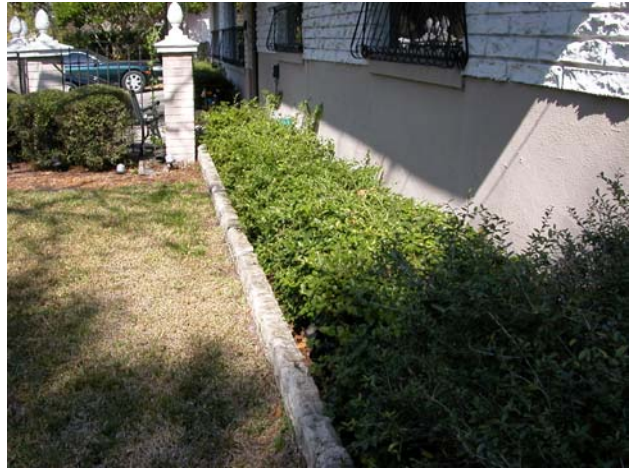
Minor Repair The planter at the front side traps water and prevents drainage. I suggest you remove it.

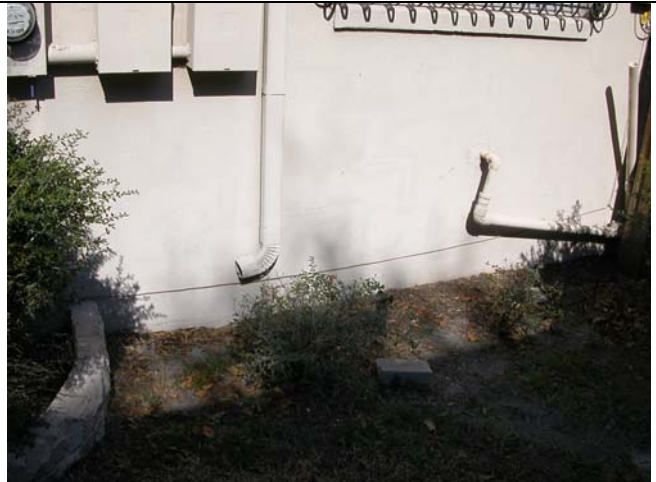
Minor Repair Minor adjustment is needed to the grading of the soil on the South side of the house to direct the flow of water away from the house. Proper grading of soil near the house is important to prevent water from accumulating near the foundation. In many instances, this has the potential to cause soil swelling and shrinking, which can cause cracking in the exterior walls or lead to water entry.

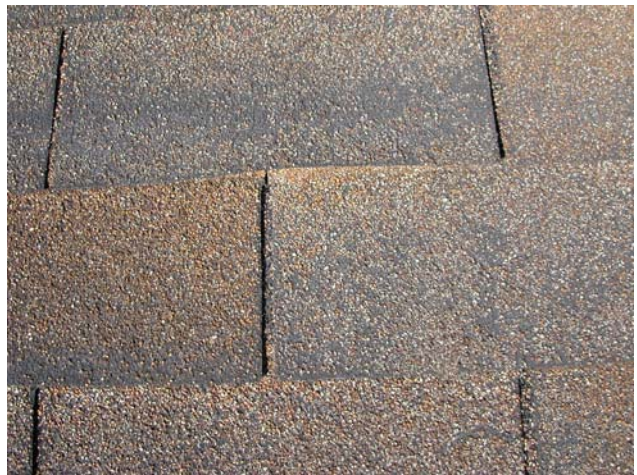
The asphalt/fiberglass shingles on the majority of the roof are at the end of their service life. They show signs of heavy wear typical for their age consisting of heavy loss of mineral surface granules resulting in areas with none left and moderate to heavy wear along the edges of the tabs. The shingles are brittle, which is a sign of aging. Cracking or splitting was observed in some areas. Some of the shingles are curling which is also a sign of advancing age.

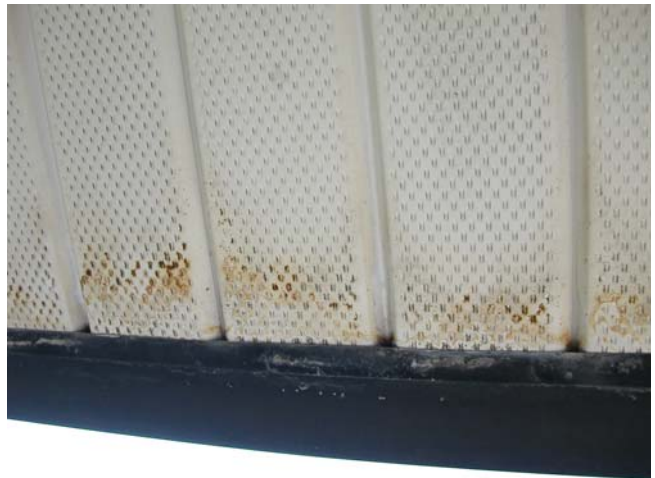
Major Repair Heavy staining is present on the aluminum soffits around the perimeter of the older roof areas in multiple locations. The stains are due to leakage at the edge of the roof. A water stain is present on the ceiling at the laundry closet. The roof needs replacement.

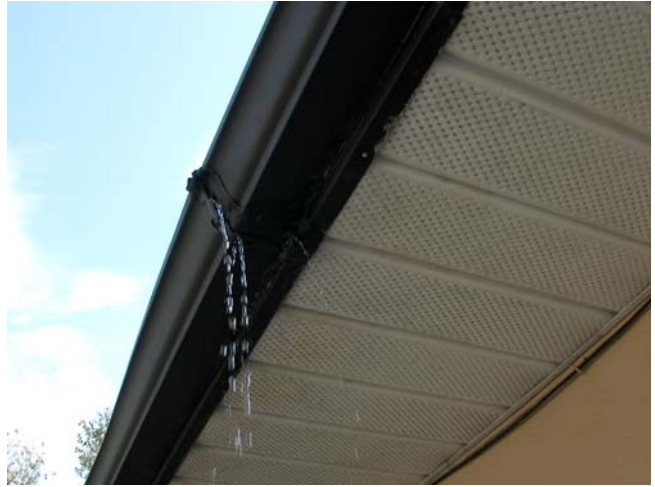
Minor Repair Gutters leak at joints.
They need sealing.

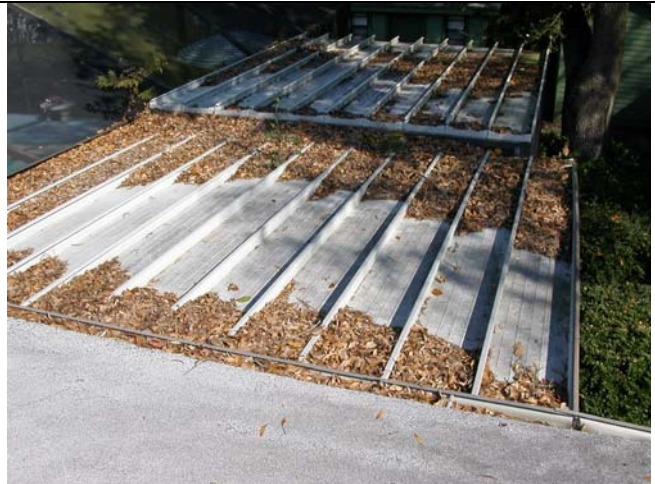
Maintenance Gutters are filled with leaves. Metal roofs at the patio are covered with leaves.

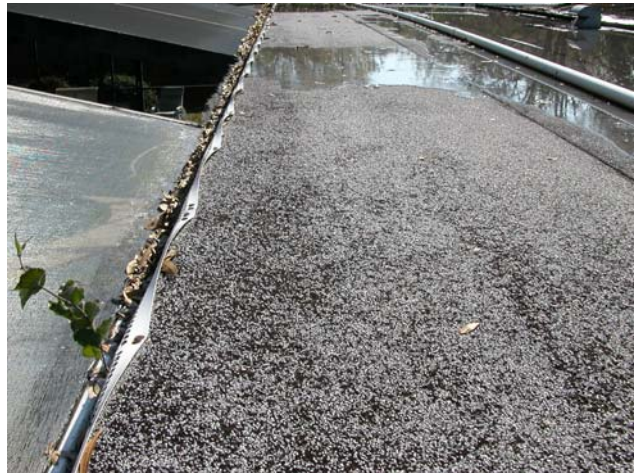
The membrane appears to be well attached to the deck, laps and seams were observed to be intact, and flashings appeared intact. Moderate to moderately heavy surface wear was evident. The roof covering appears to be in the latter third of its typical lifespan. No signs of leakage were evident. Maintenance of the seams and laps may be necessary, as they are somewhat prone to coming loose. Annual inspection is recommended.

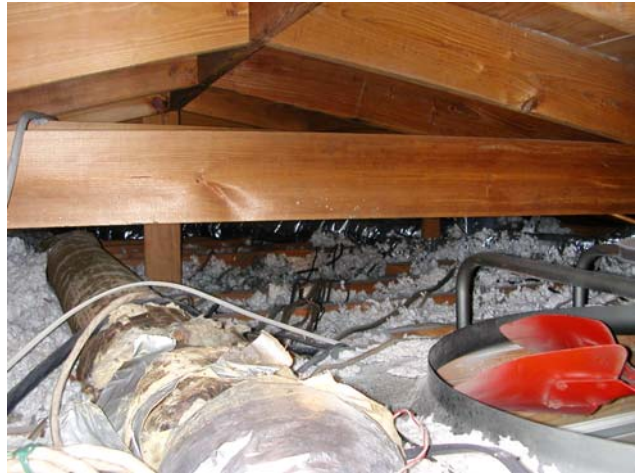
The remote areas of the attic (which includes most areas) were not examined due to limited access. Conditions in these areas (including water tightness of the roof) are unknown and are specifically excluded from the inspection and report. You should consider installing additional access openings to allow for inspection and work in the attic.

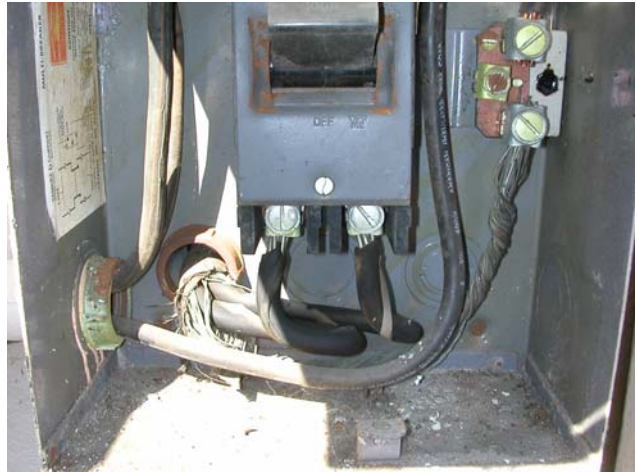
Interior of main disconnect. Old rubber insulated wiring.

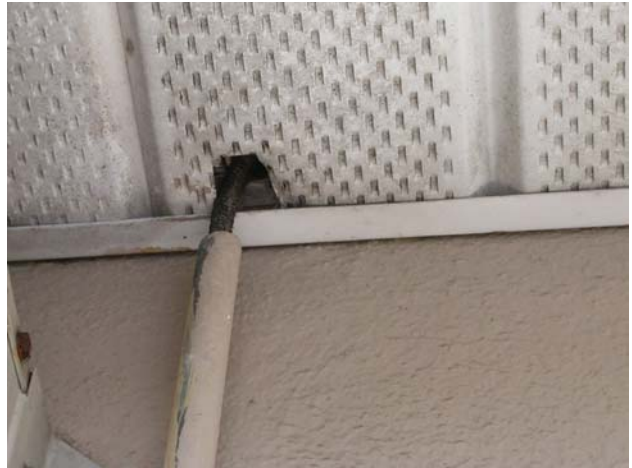
Safety Concern A wiring cable passed through the metal soffit unprotected near the wall hung heat pump.

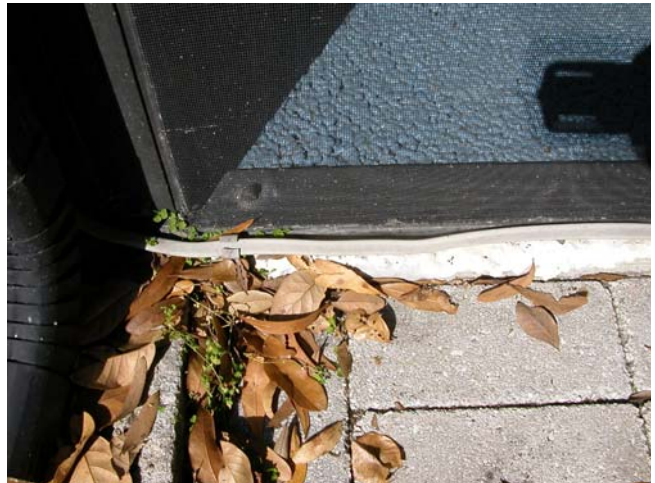
Safety Concern Wiring cables are exposed on the exterior and interior of the screen cage with no protection.

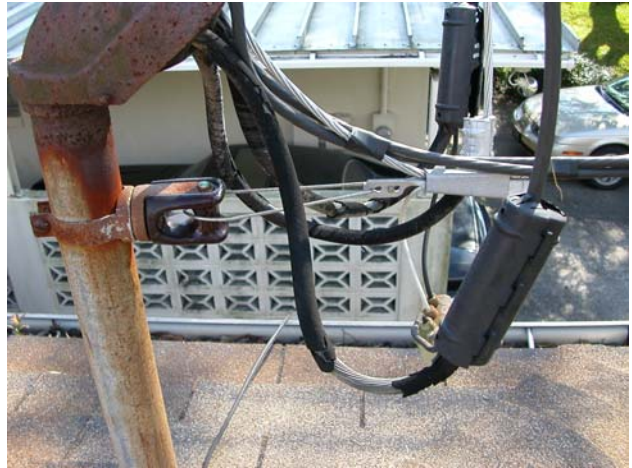
Safety Concern The insulation on the electrical service entrance wires above the roof has deteriorated exposing the live conductors. This deterioration appears to be the result of normal aging and weathering. These wires should be examined by an electrician and repaired or replaced as deemed necessary.

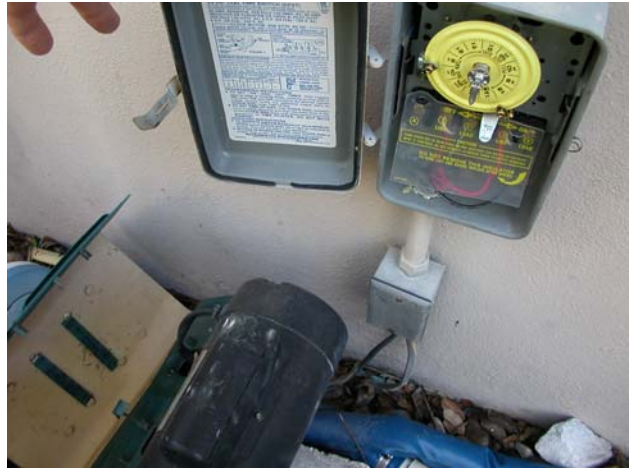
Safety Concern The pool pump time clock body is not grounded.

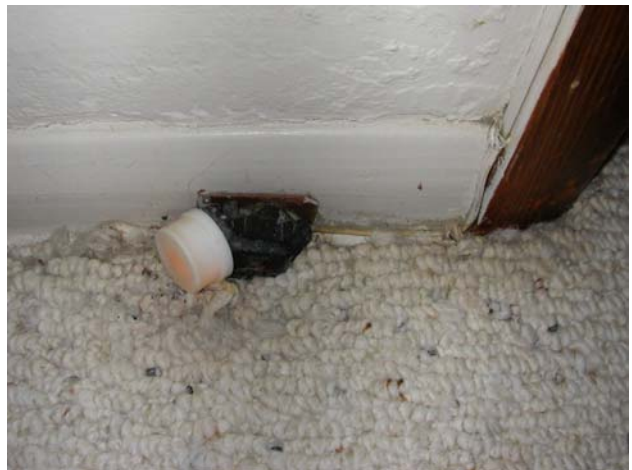
Safety Concern A lamp cord is tacked to the door casing at the master bath. It's connected to a broken receptacle with exposed live parts. Remove this.

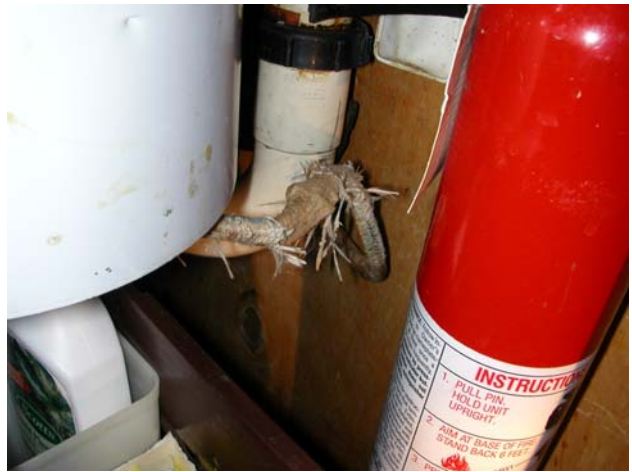
Safety Concern The exposed wiring cable at the disposer is frayed.

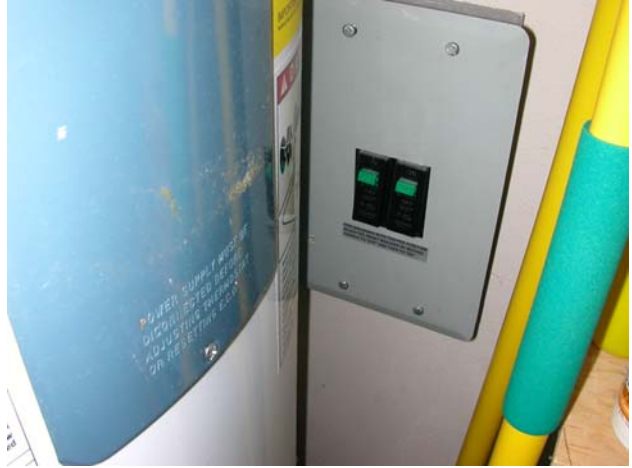
Safety Concern The disconnect at the water heater does not have access room in front of it. The handles of the two breakers should be connected.

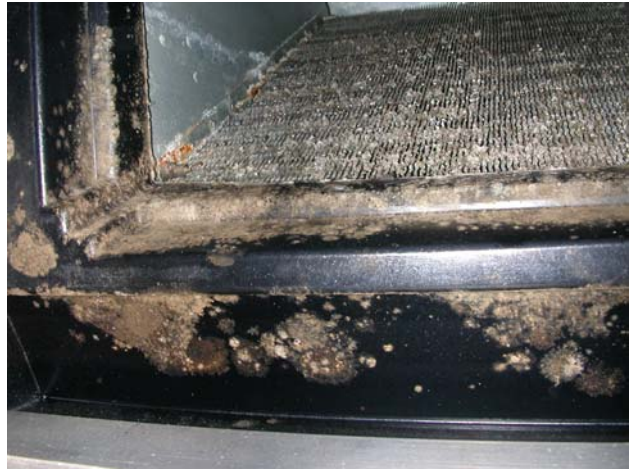
Minor Repair The evaporator coil in the air handler is dirty. This dirt may contain mold, fungus or other substances. A contractor should clean the coils in all units. The inside of the air handler should also be cleaned. The dirty coil reduces heat transfer and affects the operation of the system.

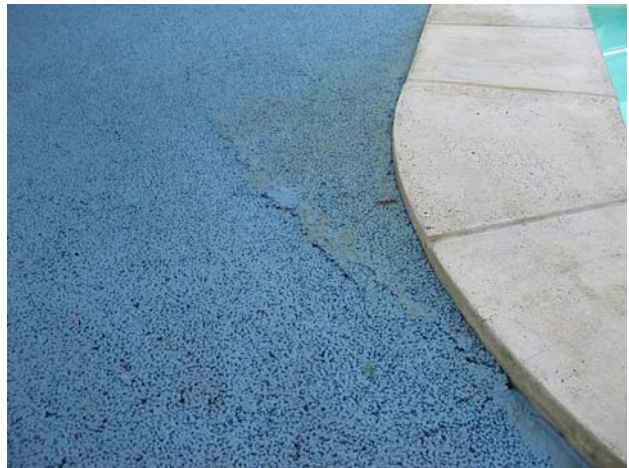
Investigate Further The concrete deck has is cracked near the South end of the pool with about $\frac{3}{4}$ " of settlement and out of plane movement. The cause of this is unknown. Uncovering the concrete may reveal some clues to the cause. The deck will need repair at some point.

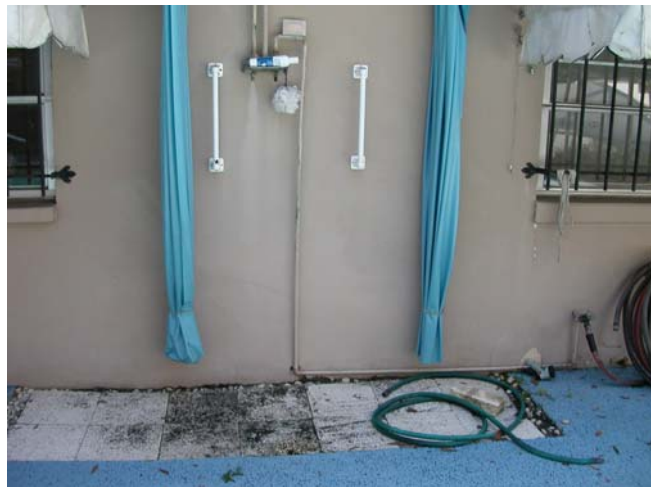
Investigate Further The pool deck slopes to the shower area at the back of the house. Water has caused settlement and cracking of the block wall of the house. Hairline cracks are present. The water should be controlled and directed away from the foundation.

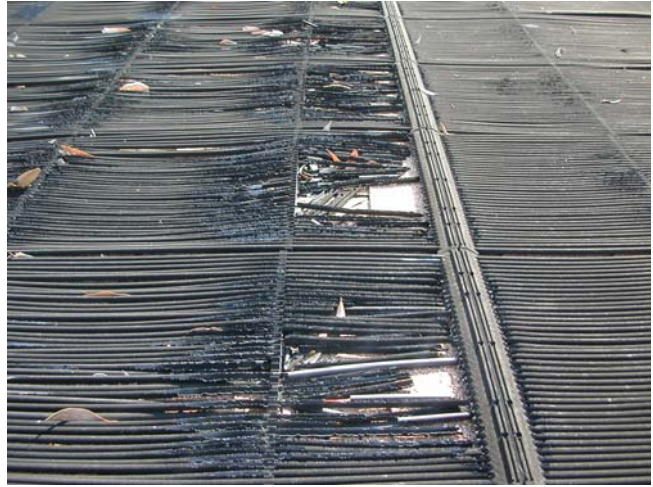
Major Repair The solar panels are heavily deteriorated. They need replacement.
