Mark Cramer Inspection Services, Inc.

Building Inspection Report

Report Number: 90002785

Address: 123 Any Street, Clearwater FL 33785

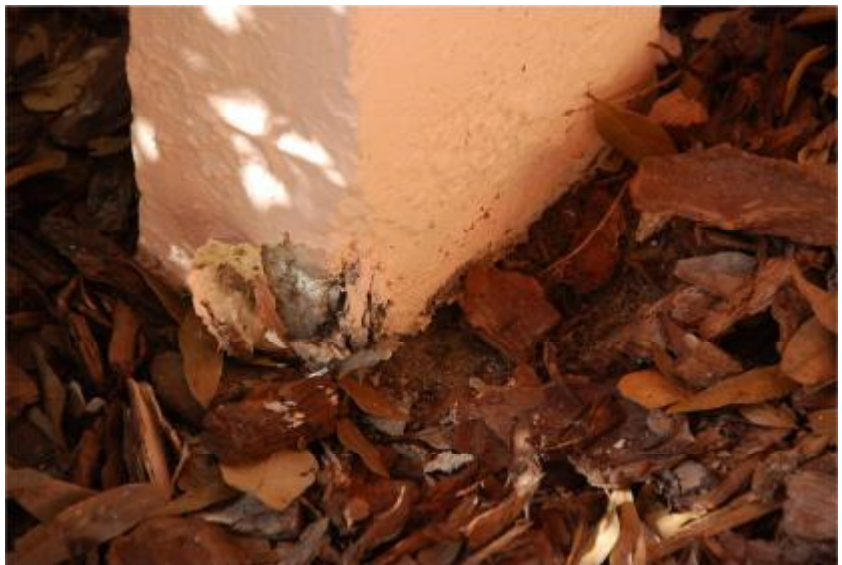
Minor Repair Minor damage is present to stucco at the base of some of the front porch columns. Repairs are needed, but not urgent.

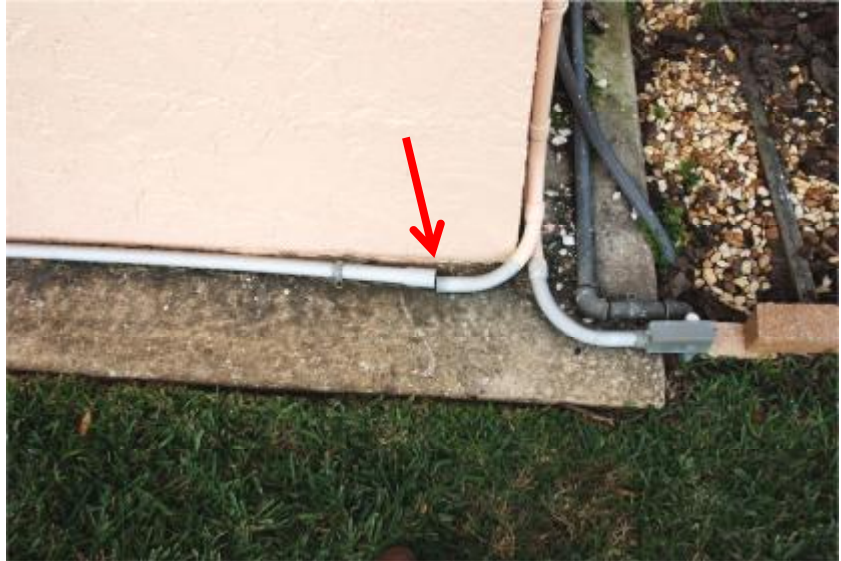
Safety Concern Plastic electrical conduit is separated at the NE corner of the house. Long runs of plastic conduit need expansion joints to prevent this.

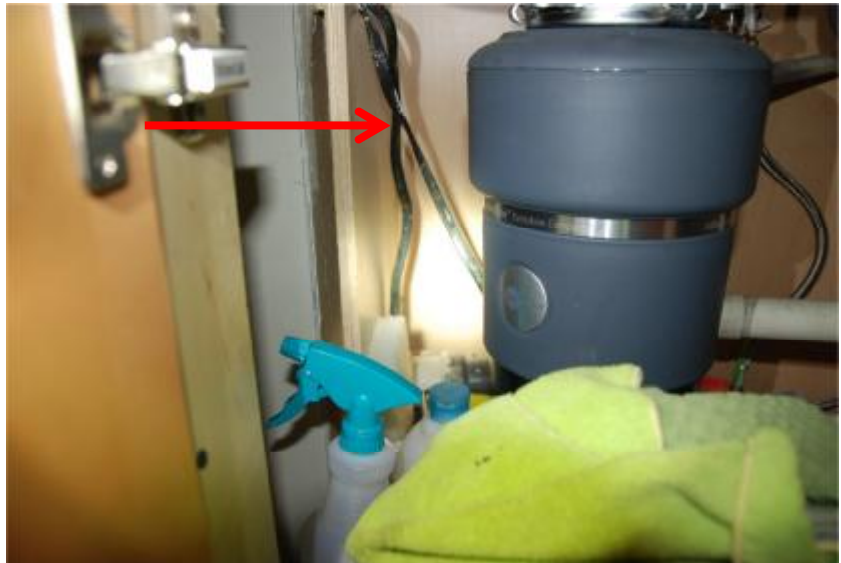
Safety Concern The nonmetallic cable to the disposer under the kitchen sink is not protected from physical damage as required for safety reasons. An electrician should install approved wiring. Cost is minimal.

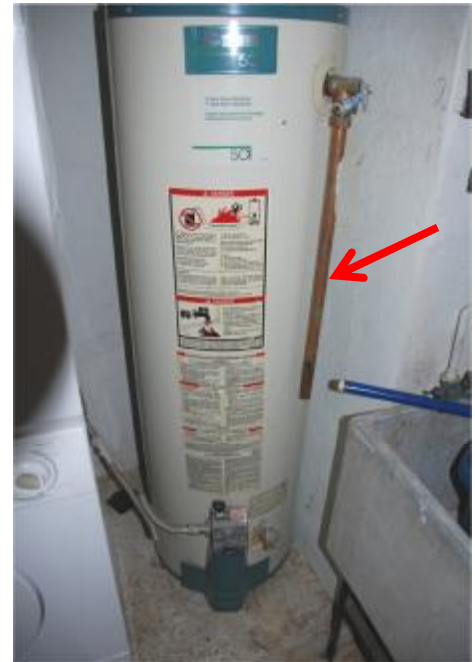
Safety Concern Piping from the water heater temperature/pressure relief valve should be extended to within 12" of the floor. In the event the water heater controls became defective and failed to stop heating, the steam and boiling hot water discharged would strike anyone standing nearby. Extension piping is required to be the same size as the valve. It may not be reduced. See the manufacturer's installation instructions for other requirements. Repair of this condition is inexpensive.

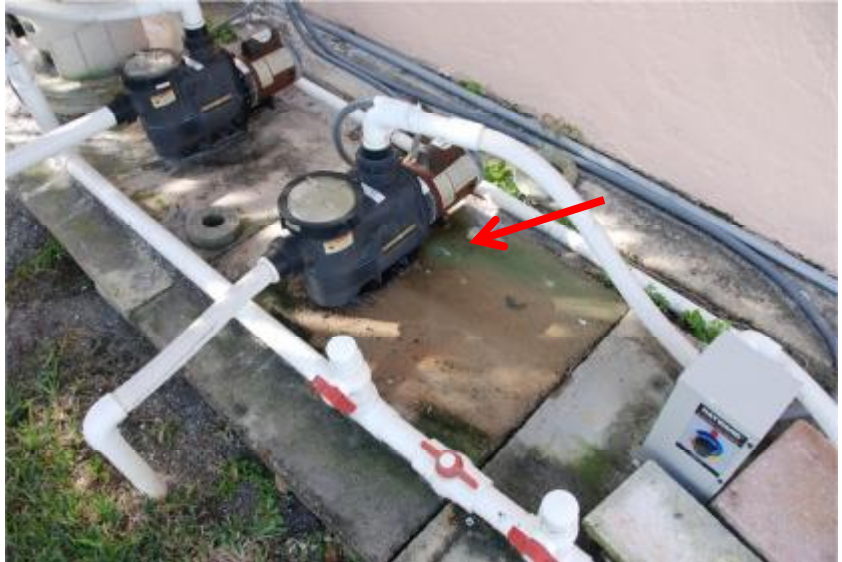
Minor Repair The pool pump is leaking at the bottom .

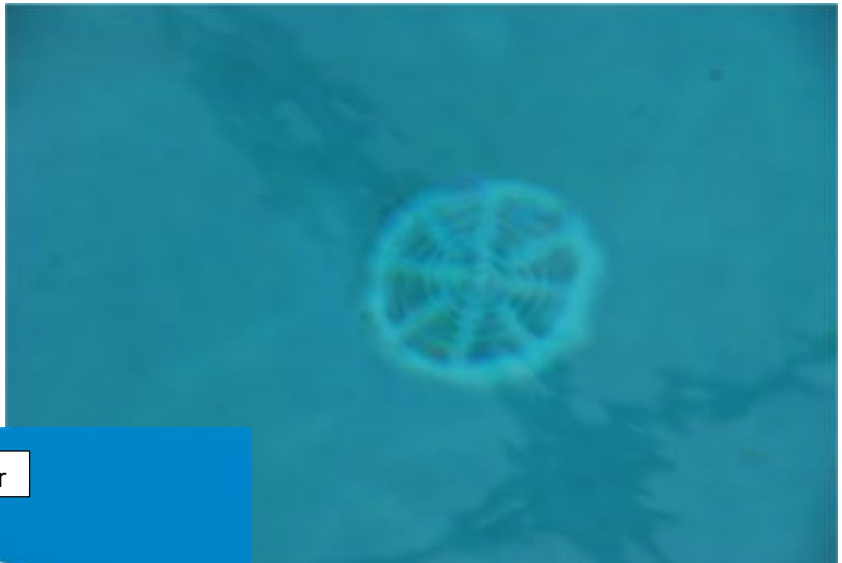
Safety Concern The main drain cover is an older type that may allow entrapment of bathers due to suction. Read this CPSC document: <http://www.cpsc.gov/cpscpub/pubs/363.pdf> Replacement with an anti-vortex type of cover is recommended to prevent this. Suction relief devices should be installed.
