Building Inspection Report

Report Number: 030406A
Inspection Date: 2/1/05 1:30

Address: 3418 Hanford Lane, Ocala FL
Reported Square Footage: 2000
Approximate Age or Year Built: 1958

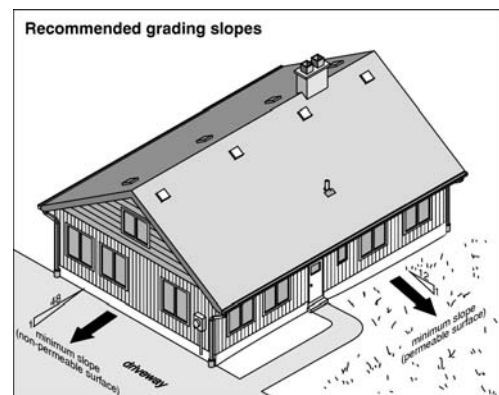
Grading is adequate in most areas. Minor adjustment is needed in some locations to divert water away from the foundation.

Minor Repair The planter at the front side traps water and prevents drainage. I suggest you remove it.

Minor Repair Minor adjustment is needed to the grading of the soil on the South side of the house to direct the flow of water away from the house. Proper grading of soil near the house is important to prevent water from accumulating near the foundation. In many instances, this has the potential to cause soil swelling and shrinking, which can cause cracking in the exterior walls or lead to water entry.
