Mark Cramer Inspection Services, Inc.

Building Inspection Report

Report Number: 90002785

Address: 123 Any Street, Clearwater FL 33785

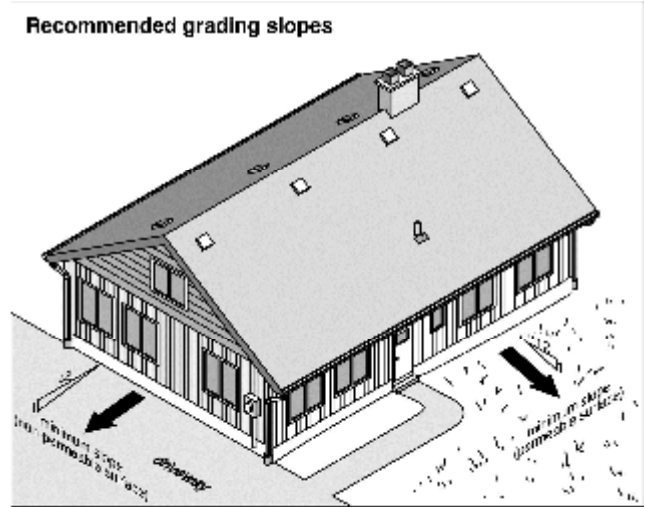
Grading is adequate in most areas. Minor adjustment is needed in some locations to divert water away from the foundation.

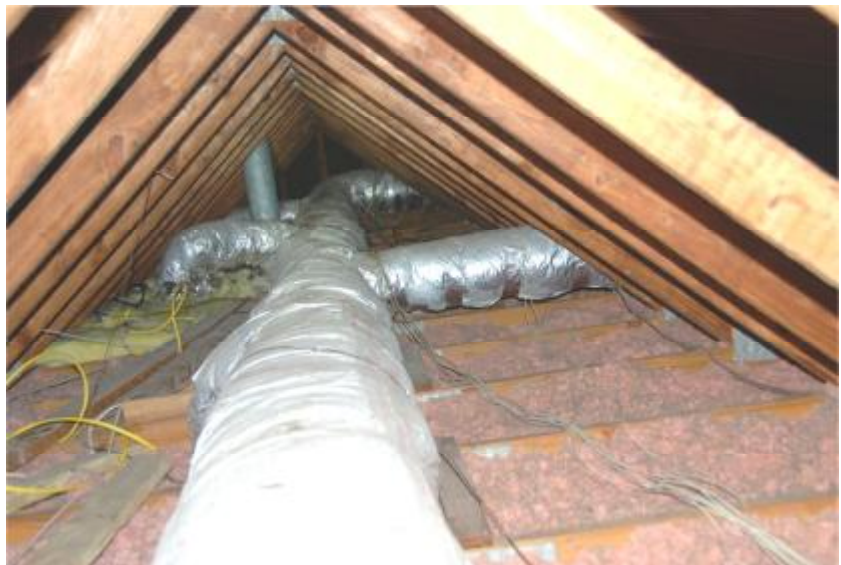
The condition of readily visible elements in the attic appears adequate except as noted elsewhere in the report. Roof sheathing and framing were examined and probed for signs of deterioration in limited areas. None were found except as noted elsewhere in the report.

We saw no evidence of leakage in the readily accessible areas.

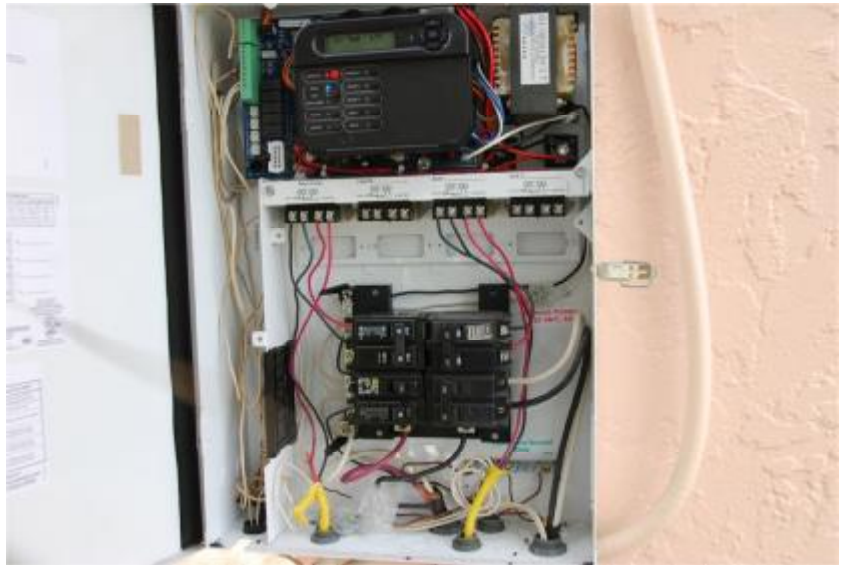
GFCI devices tested functional using a testing device. GFCI devices are not installed in all recommended locations. Upgrading is recommended.

Metal gas piping is not bonded. See repair list at end of report.

The pool equipment is not bonded properly. See repair list at end of report.

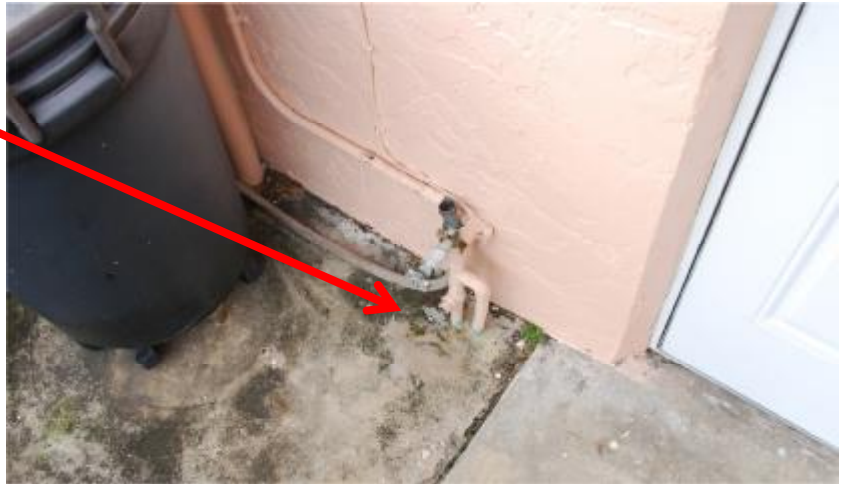
The gas 30 gallon primary water heater is located in the utility room. We estimate the age of the water heater to be seventeen years old. A temperature pressure relief valve is present on the water heater.

The main shut off valve for the water supply piping was found on the East exterior wall.

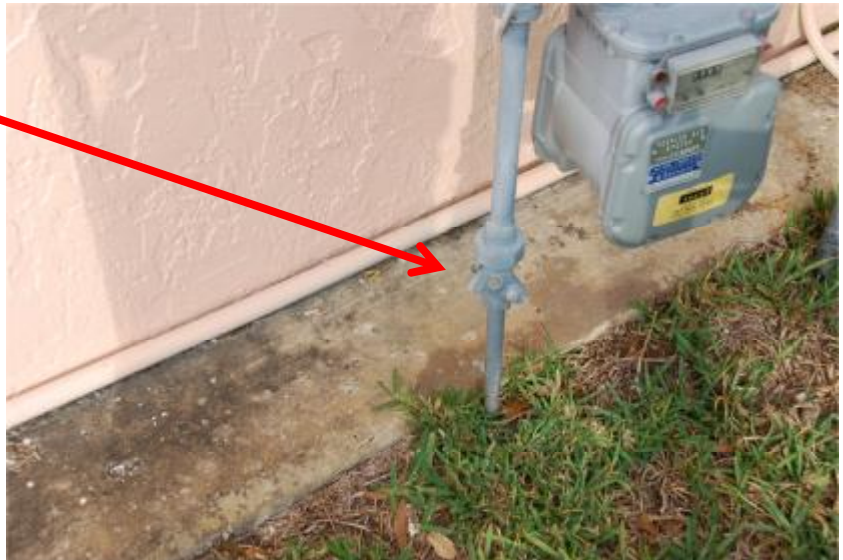
The main gas shut off valve is located on the East exterior at the meter.

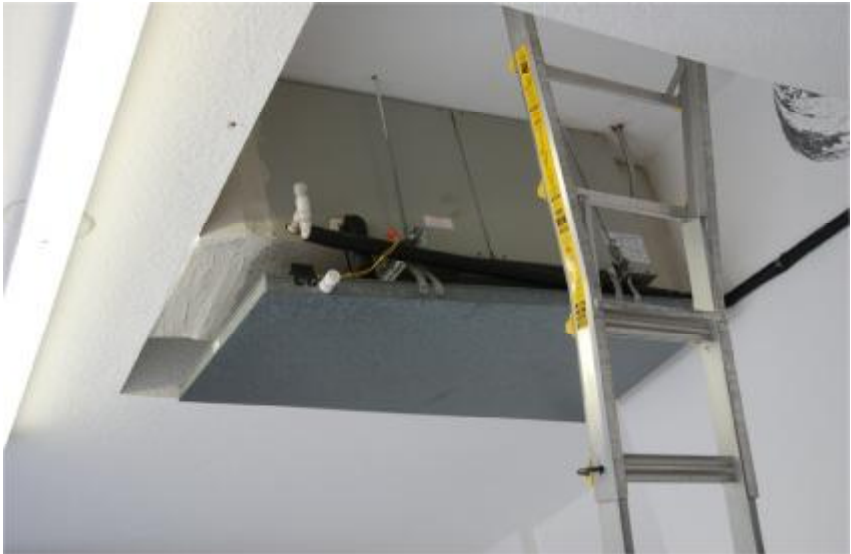
The estimated size of the system is three and a half tons.

The estimated age of the cooling system is ten years old.
